**Supplemental Information for the
Alluvial Valley Floor
Investigation at the
North Private Lease Area**

**Alton Coal Development, LLC
Coal Hollow Mine**

October 10, 2014

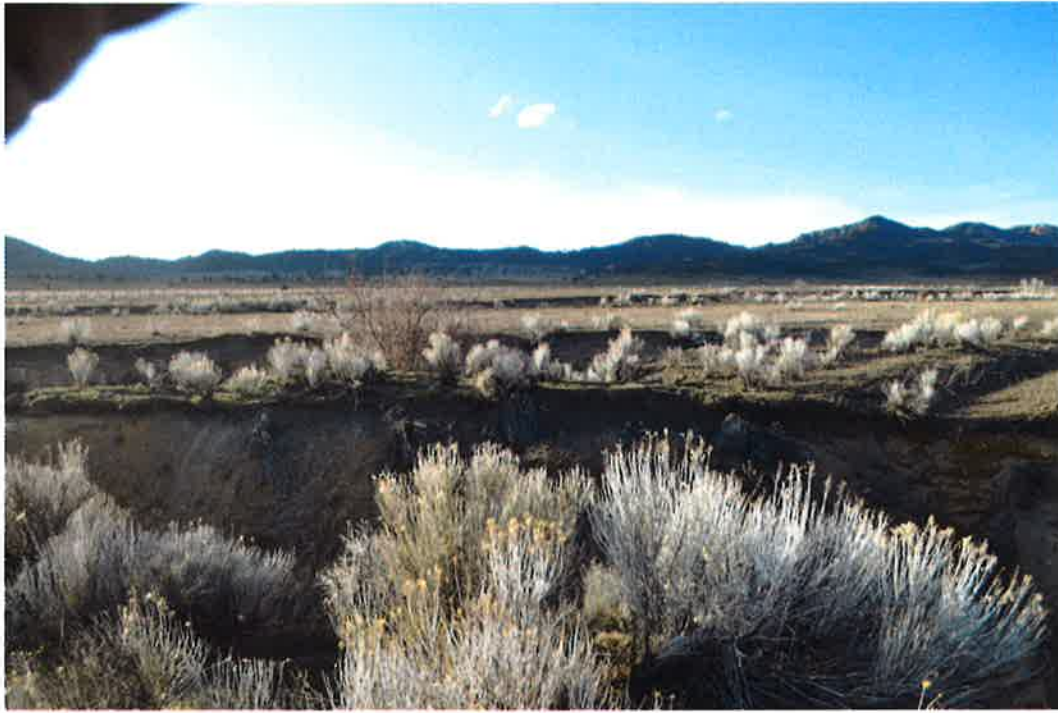
Photograph 1

Fields of North Private Lease Area. Note deeply incised channels and isolated plateaus/terraces with steep erosional escarpments in soft sediments.

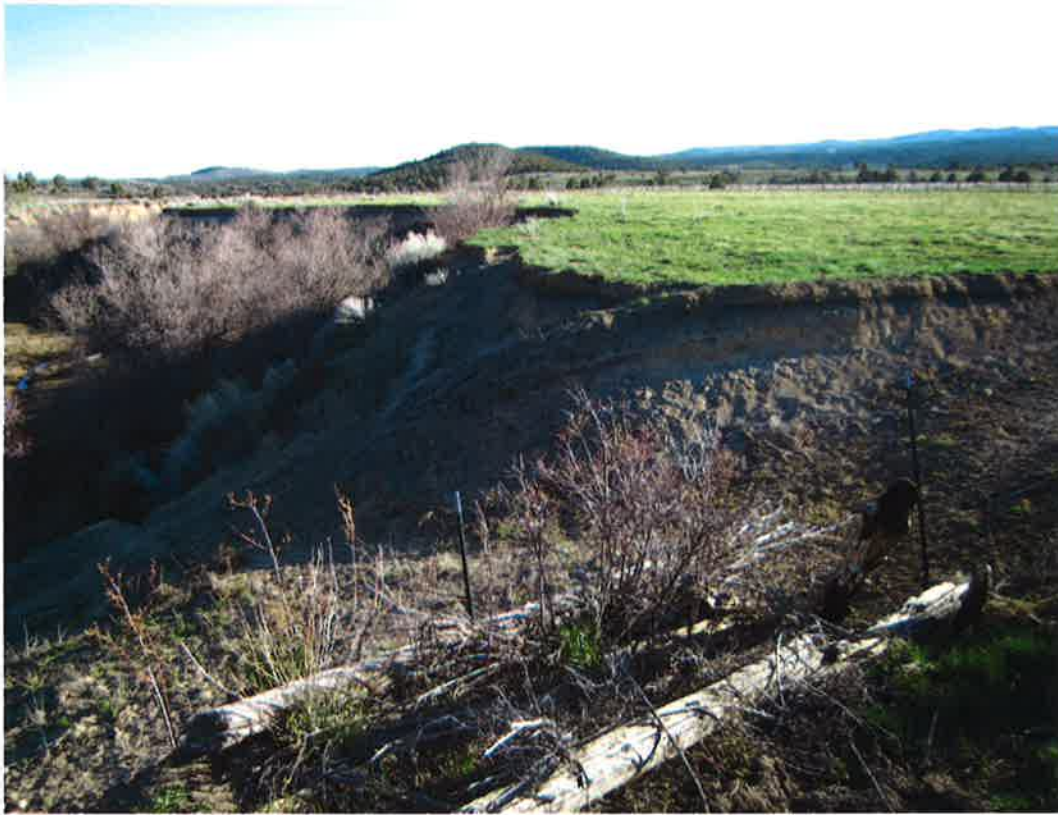
Photograph 2

Fields of North Private Lease Area adjacent to Kanab Creek. Note plateau/terrace topography and erosion along margins of field.

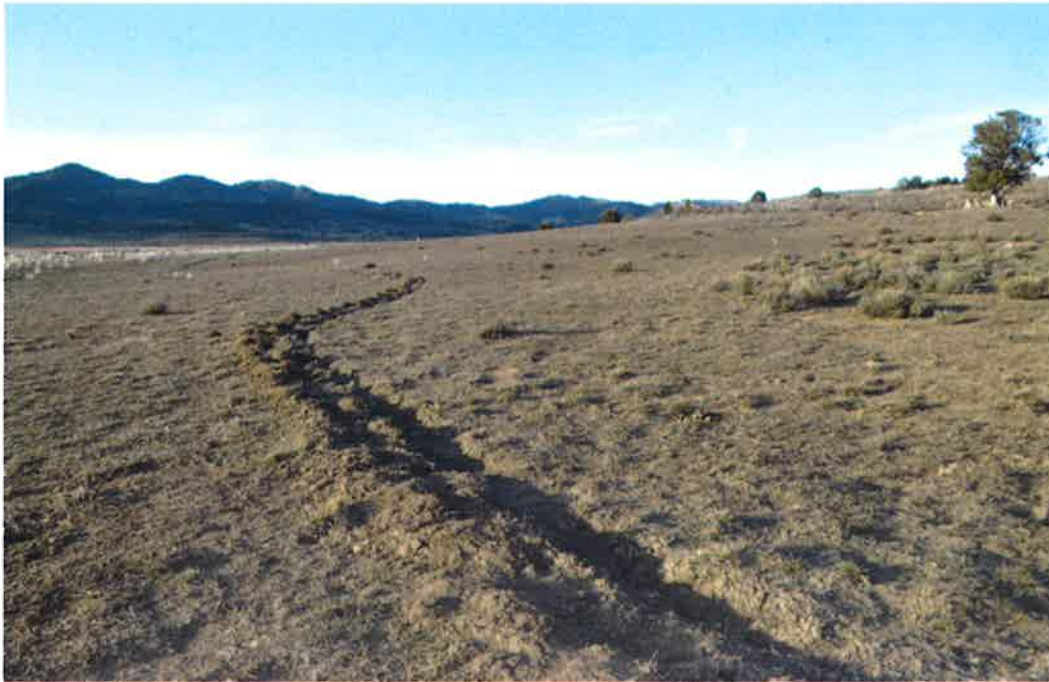
Photograph 3

Sloping hillside on east side of Kanab Creek. Note the excavated ditch/trench. Landowner (C. Heaton, 2014) indicates that this trench was dug to prevent erosion of fields below from surface-water runoff over escarpment plateau/terrace topography. Mr. Heaton indicated that most of the ditch-like structures in the area are for erosion control.

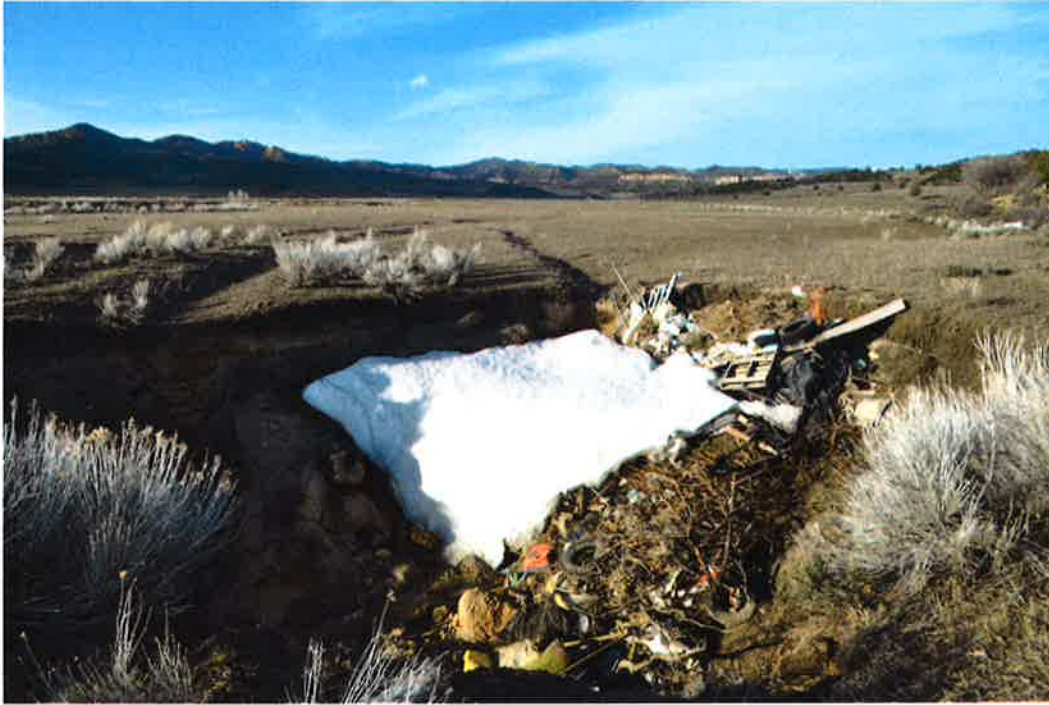
Photograph 4

The terminus of the trench/ditch structures shown in Figure 3. Note the extensive erosion and the landowner attempts to prevent upward migration of the erosional scour by placing all manner of rip-rap at the erosional face.

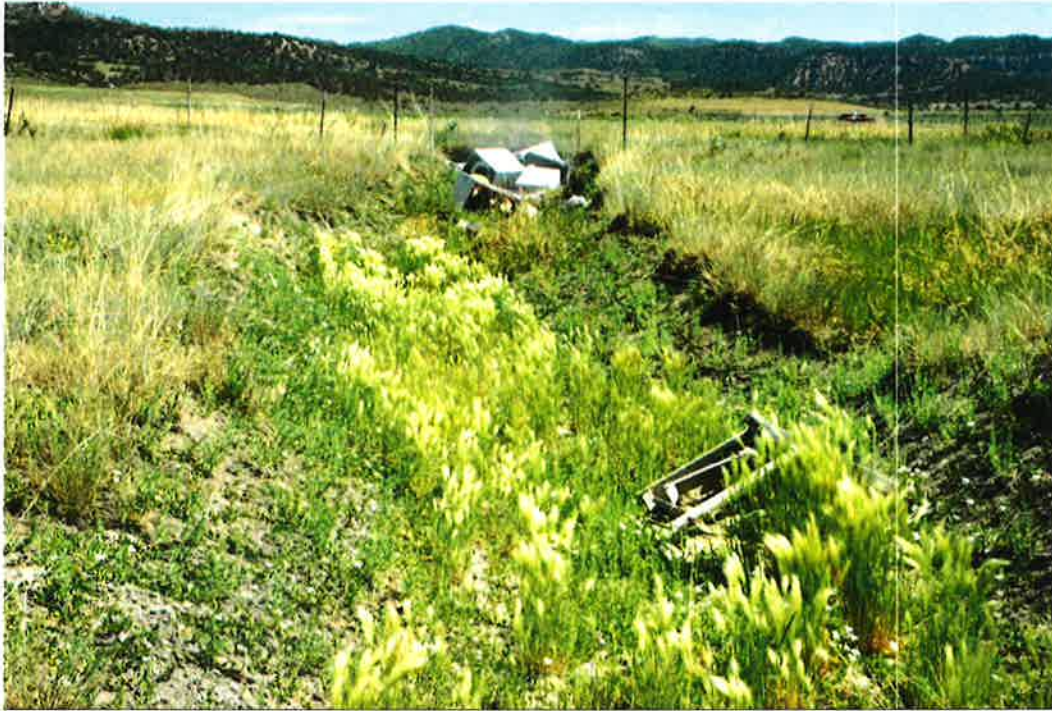
Photograph 5

Headward erosion and landowners attempts to stop the upward progress of the erosion in the North Private Lease Area.

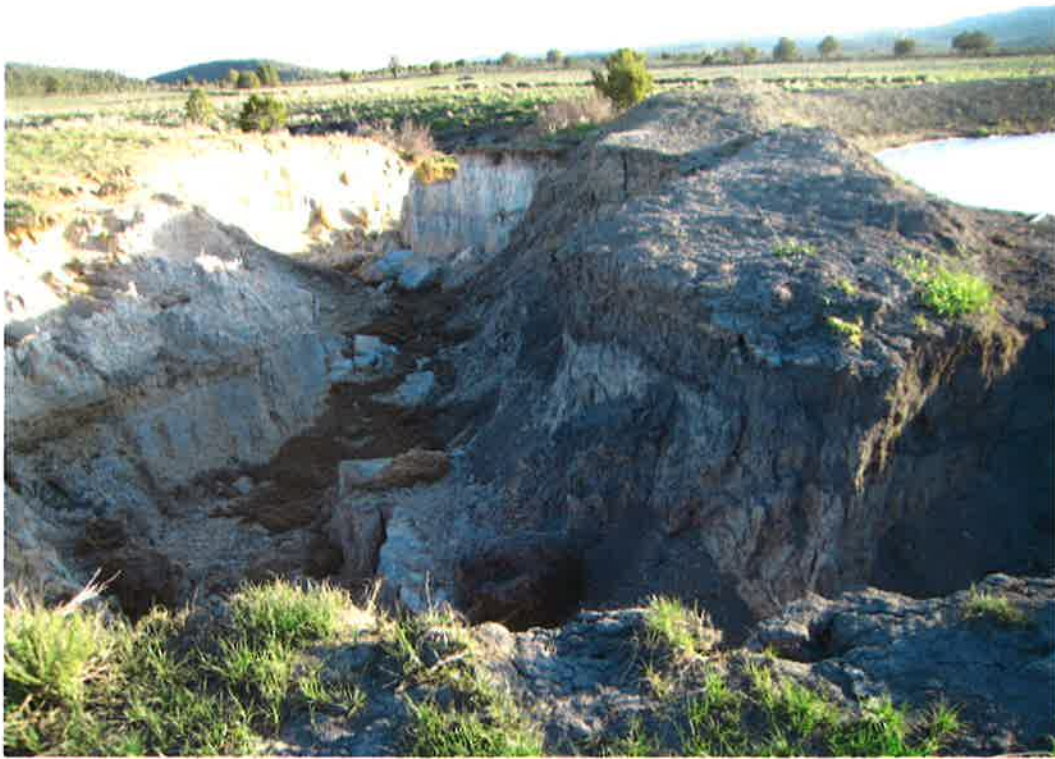
Photograph 6

Outlet from stock watering pond immediately south of elk fence along western margin of North Private Lease Area (Photo from May 2008). Note extreme erosion of soft sediments below the pond outlet. Subsequently, this pond/dam was washed out around February 2012.
